PBD-02-001 PSC INSPECTIONS

1. PSC MOST COMMON ISSUES
2. PREPARATION FOR INSPECTION
3. MLC PROBLEMATIC ITEMS

PDB-02-001

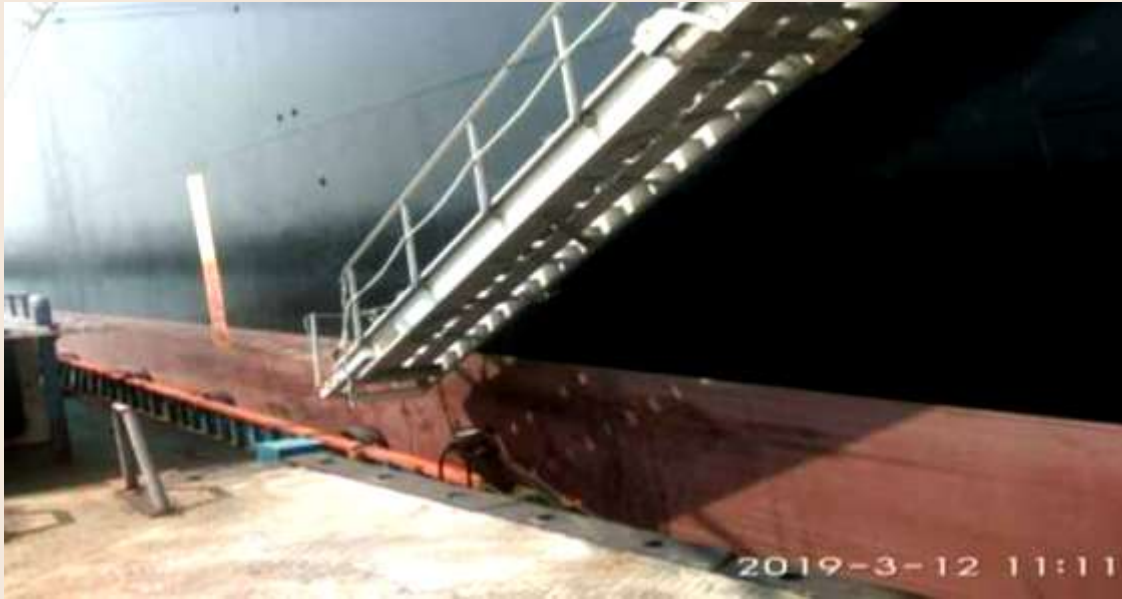
Gangway is not provided with safety net

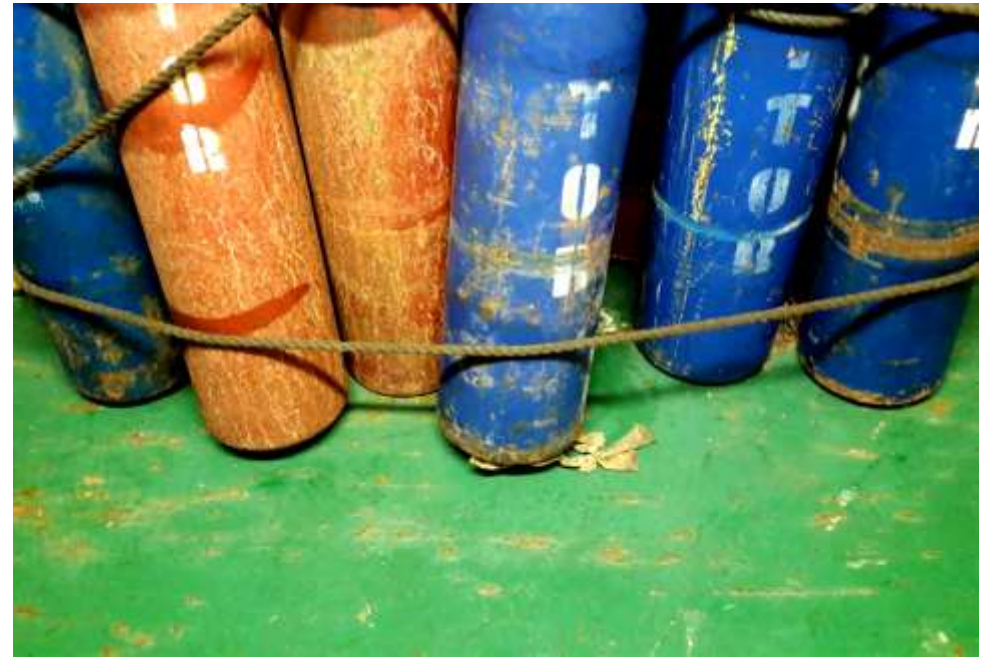
Improper stowage and securing of oxy/acetylene tanks

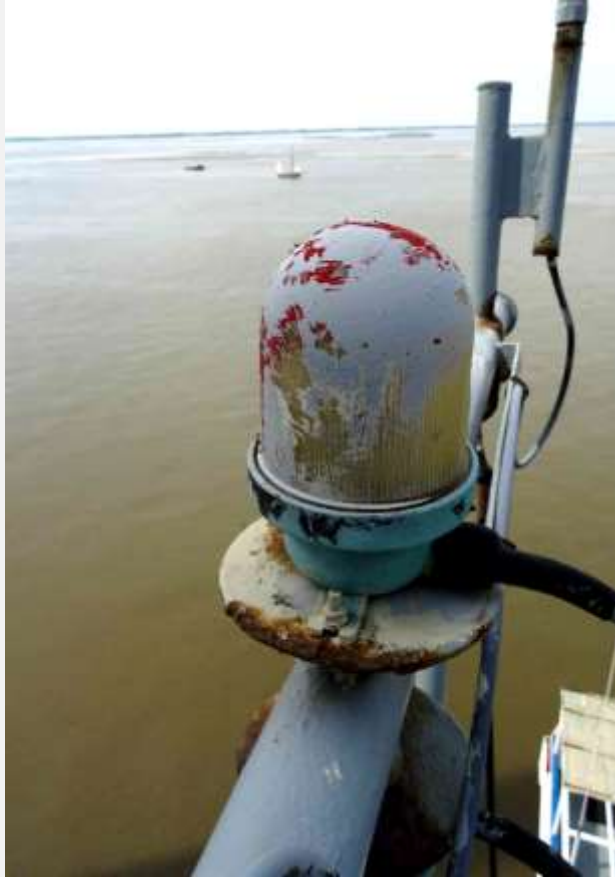
Navigation light cover was painted over

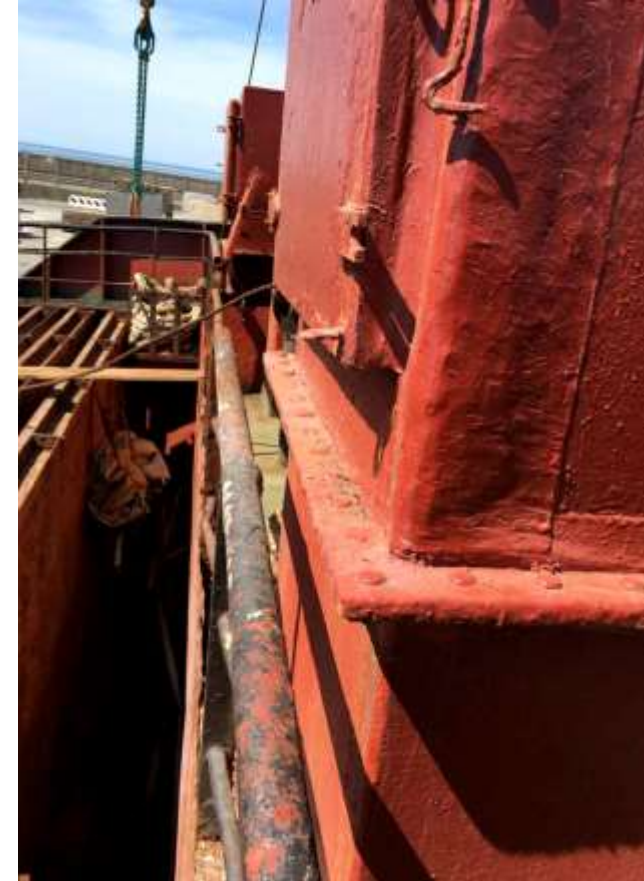
Missing securing bolts / butterfly nut for ventilation cover,
vent cover welded to structure and corroded handrails

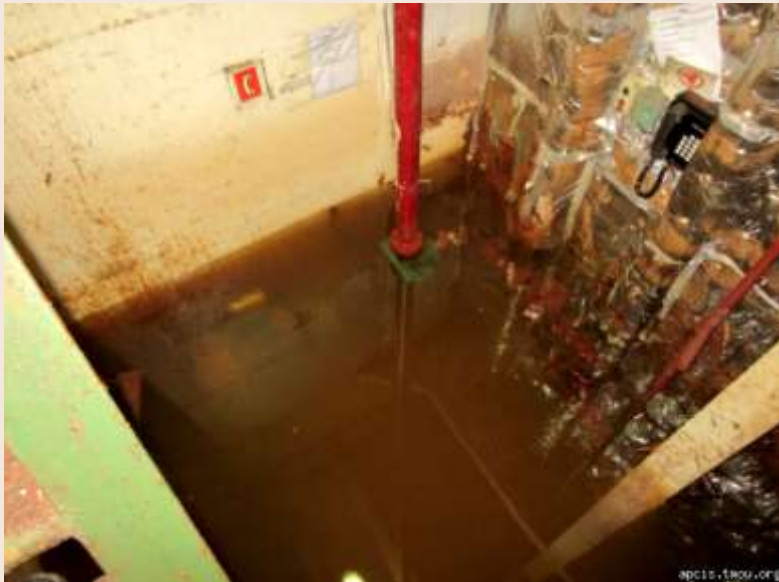
Flooded emergency pump room

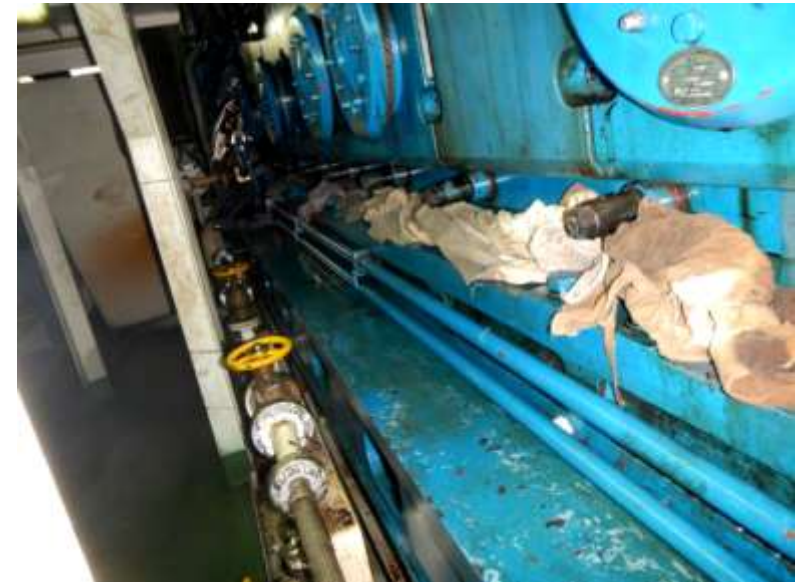
Oily rags placed around the engine (fire hazard)

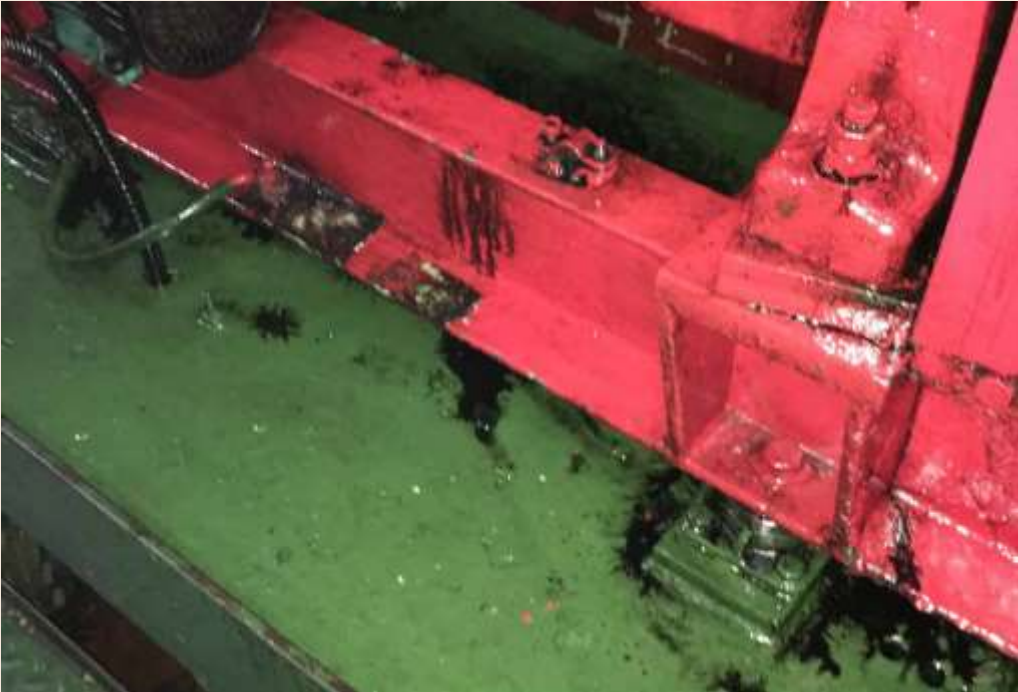
Oil around engine machinery / poor housekeeping

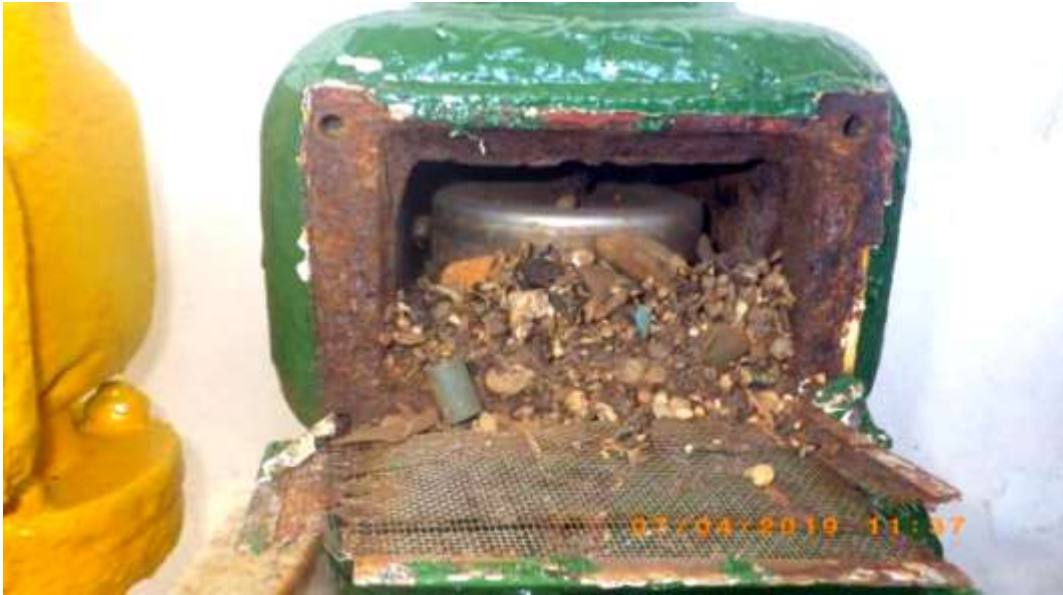
Corroded/damaged ballast vent head cover

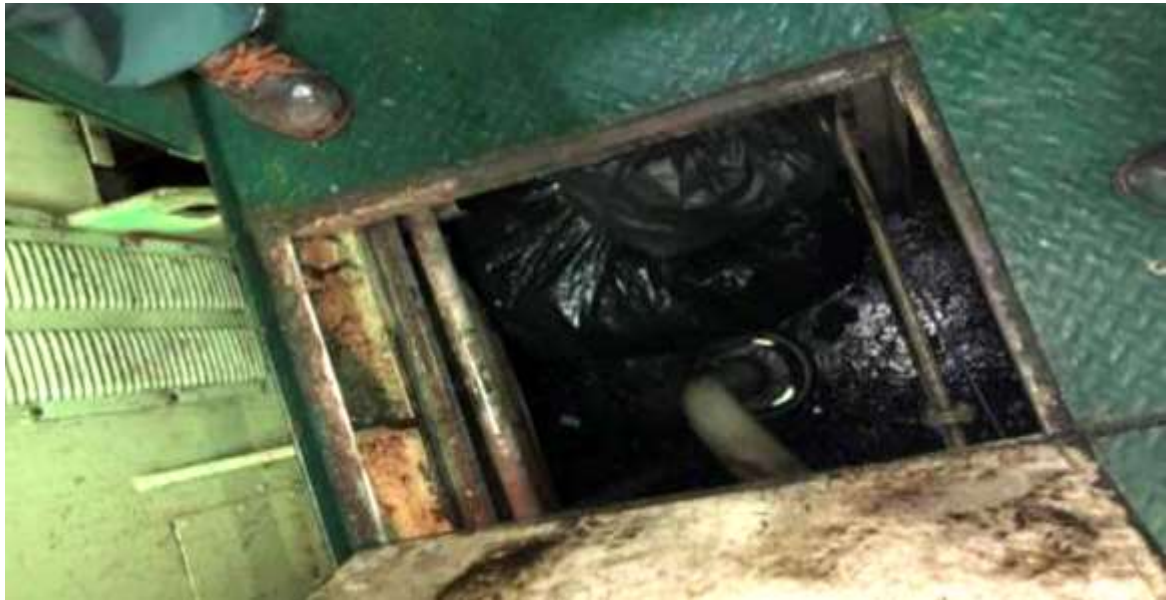
Garbage bags stored under the engine room gratings

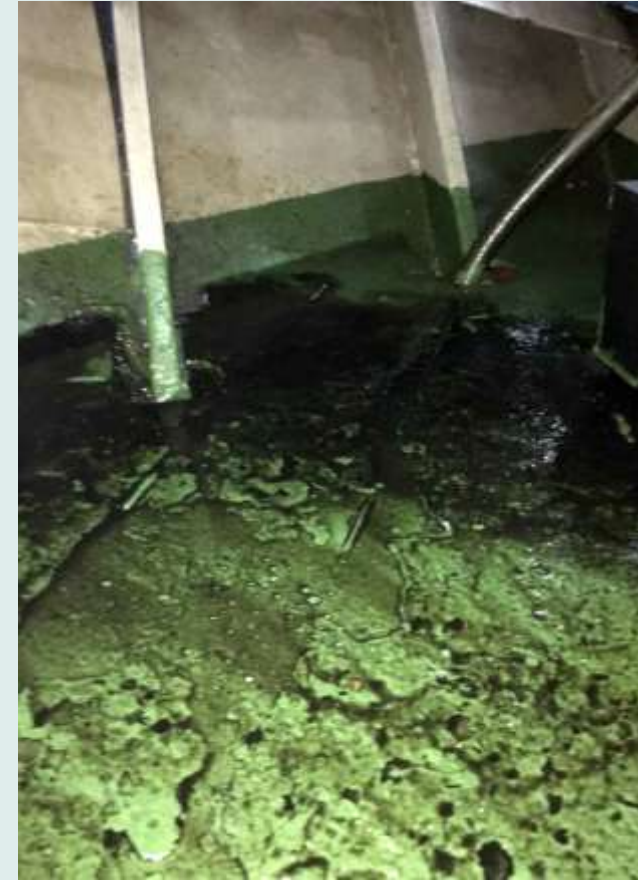
Oil on engine room flooring

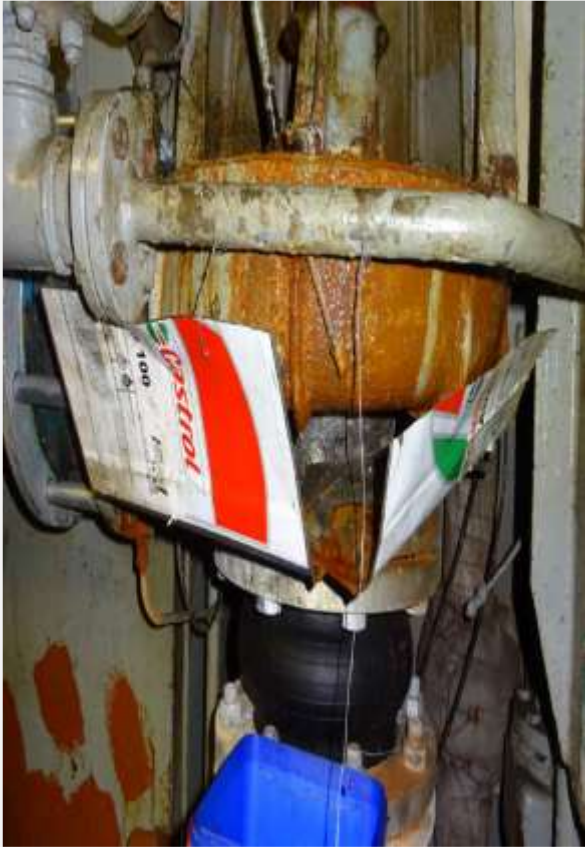
Corrosion due to leaking machinery pump and illegal drip pan/bucket underneath

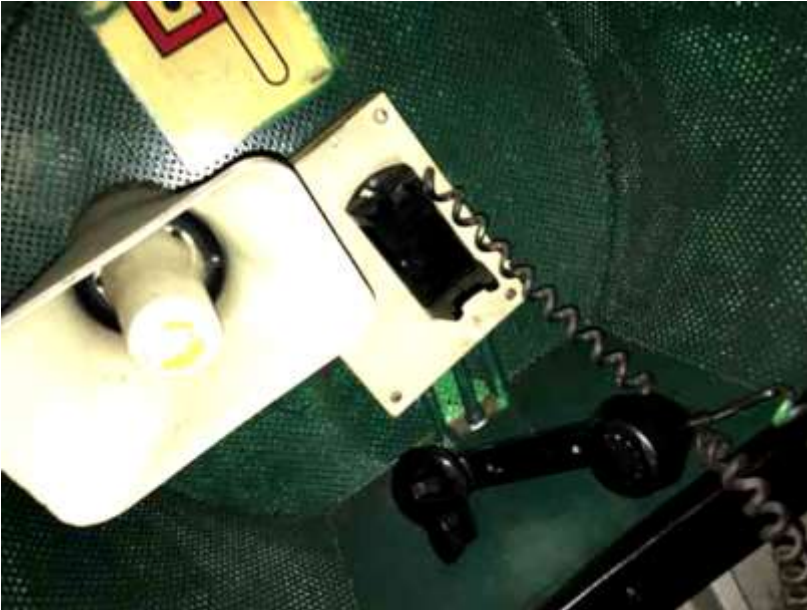
Telephone handset not properly secured. Damaged holder

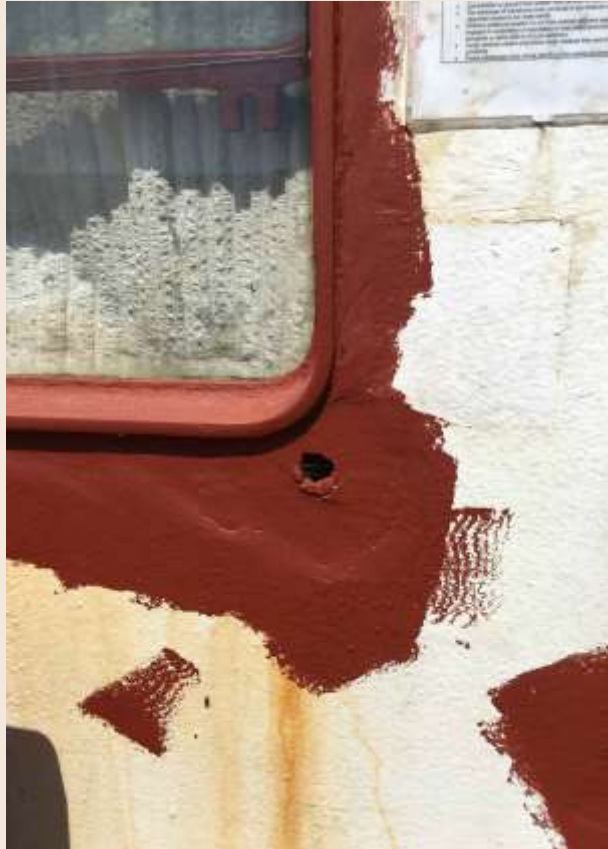
Hole on the accommodation structure

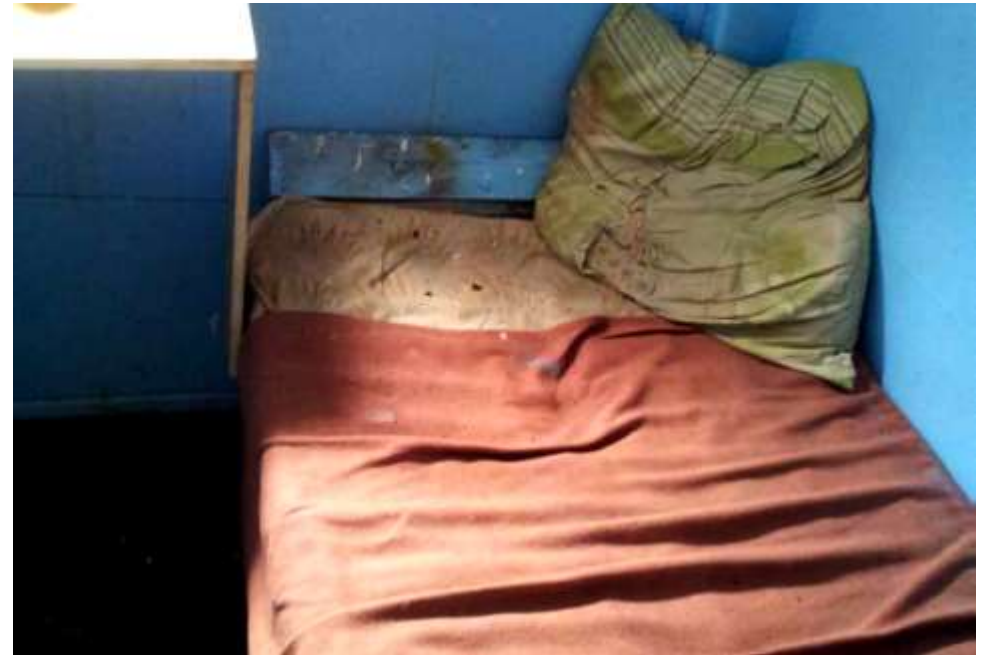
Filthy / sub-standard cabin

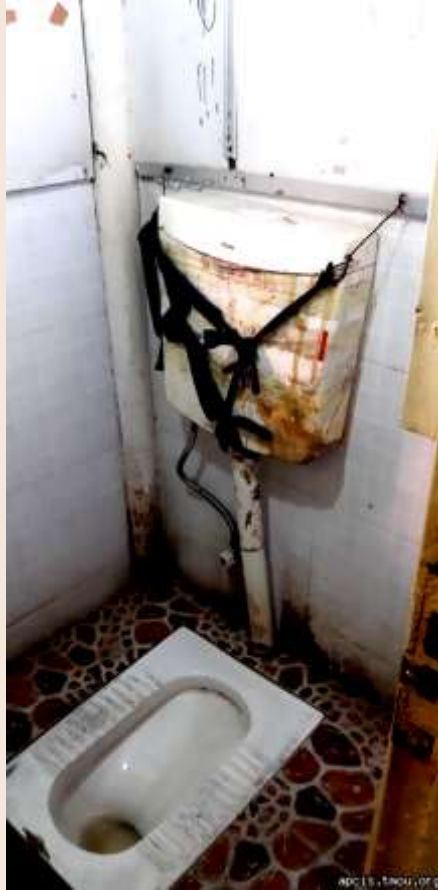
Damaged toilet flush tank

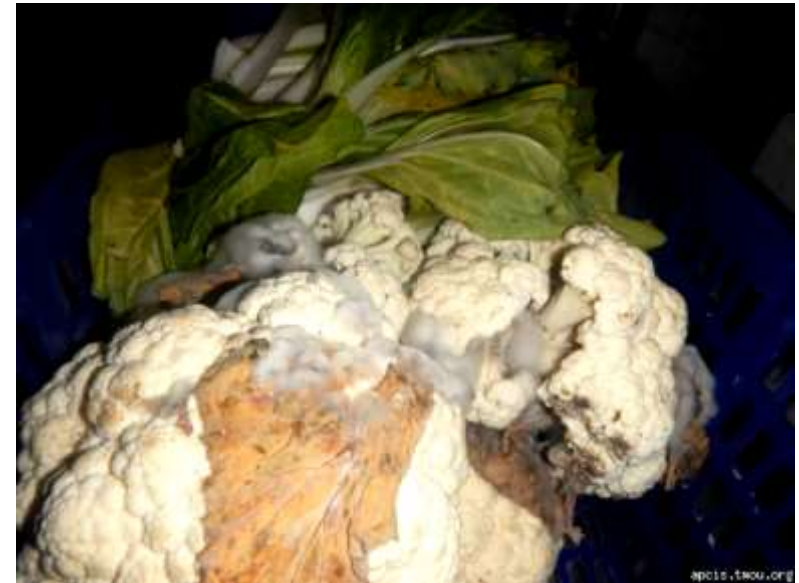
Rotten vegetables
