FIRE DURING HOT WORKS

PDB-10-000

- When : 10-02-2020
- Where: at Sea

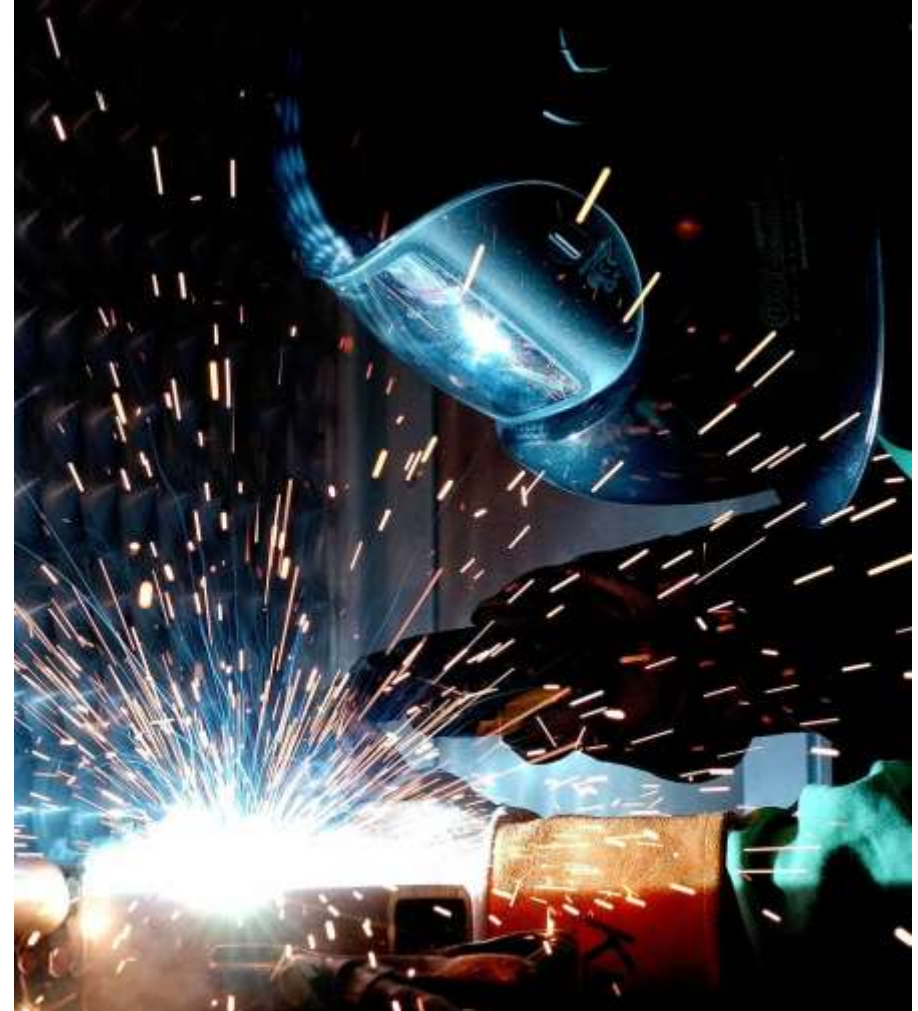
- On 09-02-2020 was found that hydraulic pipe of stbd mooring winch is leaking
- 10th of February oil was drained from the stbd mooring winch hydraulic system and area was prepared for hot work
- 15:35 - Commence of hot works to dismantle the old leaking pipe.
- 16:10 - Ch.Officer(st-by person) reported that "fire in the forecastle switch room"
- 16:12 - Attempt to extinguish the fire with fire extinguishers with no positive result.
- 16:15 - Crew on st-by, ventilation/fire flaps closed, electrical supply of the forecastle switched off.
- 16:28 – Fire squad reached the centre of fire fighting area (switch room).
- 16:36 - Fire completely extinguished. All men out and safe.
