FIRE DURING HOT WORKS

PDB-10-000

- When : 10-02-2020
- Where: at Sea

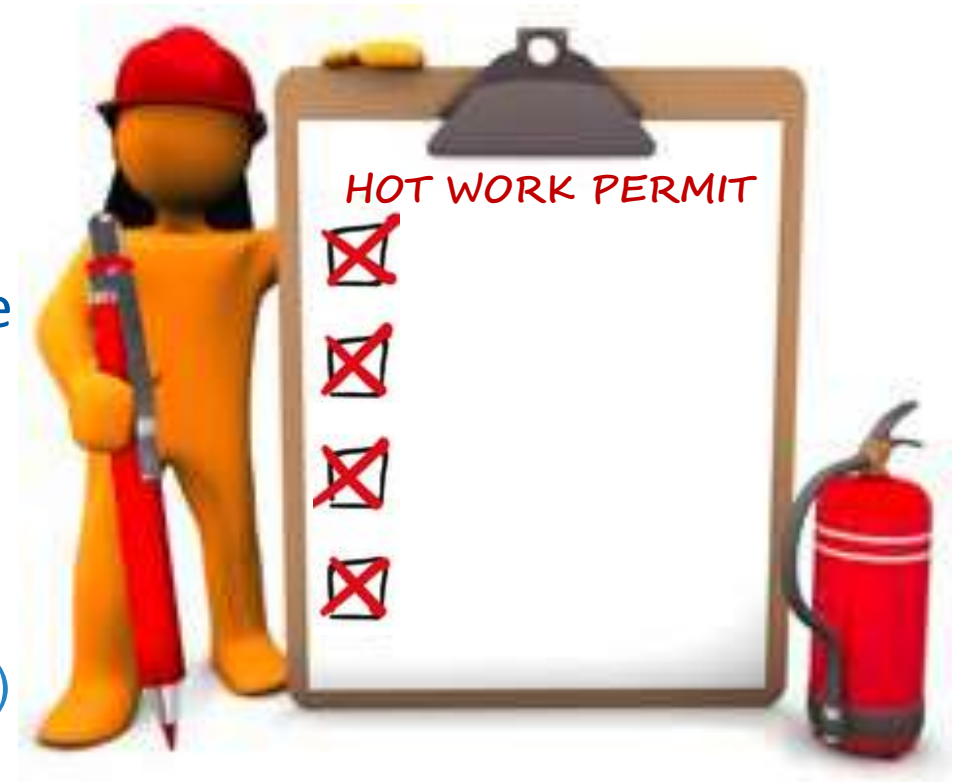
- Main cause of fire was that crew overlooked fact that the **ceiling** and the **wall had partly an oily surface**. The spark reached the oily area and later **fire jumped to the stored, used safety equipment** (old fire box and used fire hoses) **which was not moved out** from the working area far enough.

- HOW THIS COULD BE PREVENTED ?
 - Risk assessment prior starting of works
 - Proper preparation of area where hot works will be removal of flammable materials.
 - Fire extinguisher available next to hot works area
 - Exact check of arrangements by superiors

(All points are part of HOT WORK PERMIT PROCEDURE)
